# Accurate Home Inspections of Illinois inc.

## Home Inspection Report For Greg Harwood 26237 Whispering Woods Circle, Plainfield, Illinois 60585

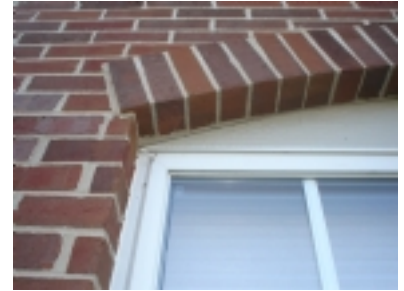
REPAIR or REPLACE - Caulk, sealant and/or flashing detail is deteriorated, damaged or otherwise not effective. In my opinion this can increase the chances for water leakage and other moisture problems. This can lead to various damages such as at the drywall, plaster, flooring, insulation and structural framing. Water leakage and moisture problems can also lead to a mold problem. Appropriate corrective action is recommended by a qualified contractor.

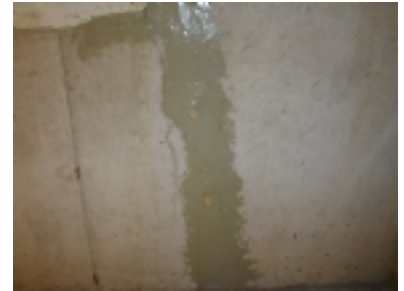
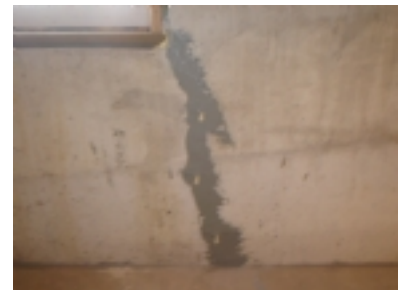
INFORMATION - There are one or more repairs made to the foundation with a process commonly referred to as epoxy injection. This repair generally suggests cracking and previous water leakage. The epoxy injection is a repair for water leakage. This inspection cannot determine the effectiveness of the repairs or if additional repair will be needed.

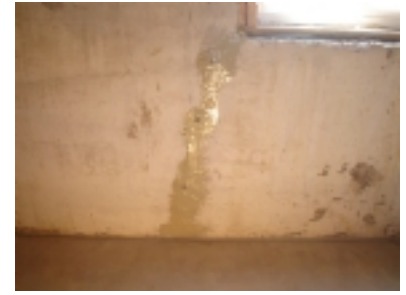
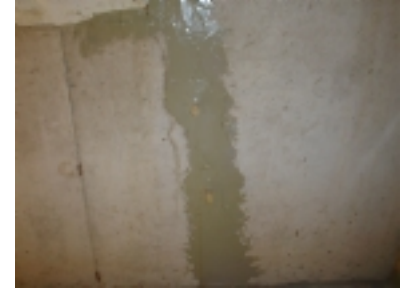
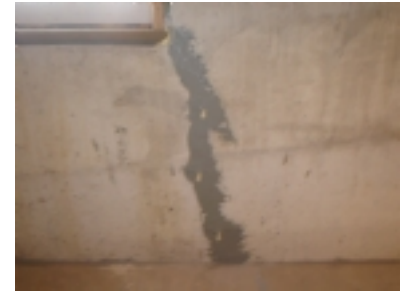
INFORMATION - Indicators of past repairs are present. I recommend you request any and all information regarding these repairs. It is not within the scope of this inspection to determine the appropriateness or effectiveness of any repairs or their sustainability.

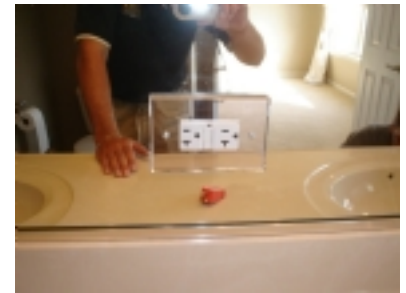
SAFETY / MAINTENANCE - Cover plates are loose at receptacles at one location. All switches and receptacles need to be covered so there are no exposed wires or terminations. Exposed wiring and terminations is considered to be a safety hazard with the increased potential for shock and fire. Appropriate cover plates are recommended.

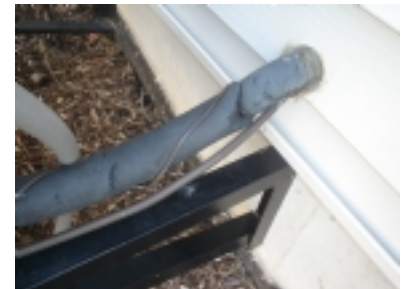
REPAIR or REPLACE - The refrigerant lines are damaged. In my opinion this can have a negative effect on the operation of the air-conditioning system, can lead to leaking and malfunction. Appropriate corrective action is recommended by a qualified HVAC contractor.

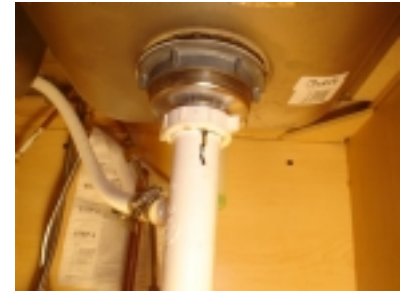
REPAIR or REPLACE - There are indicators of a water leak. This inspection cannot determine how severe, if corrected or how effective any repairs may be if repairs have been made. Water leakage and other moisture problems can lead to various damages such as at the drywall, plaster, flooring, insulation, structural framing and other building materials. Water leakage and moisture problems can also lead to a mold problem. Appropriate corrective action is recommended by a qualified contractor.

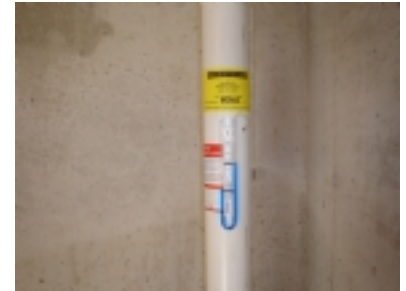
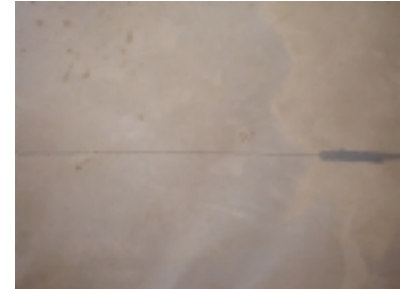
SAFETY - Environmental conditions are excluded from this inspection report. However, a radon reduction system is present in this home. This inspection cannot and does not determine its effectiveness or current radon levels. In my opinion you should consult with a qualified radon professional to determine the effectiveness of the system, appropriateness of installation and current radon levels. Radon gas is a known carcinogen.

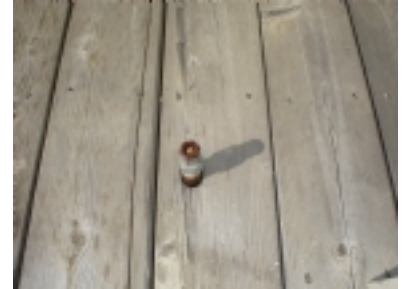
The gas hook up for the grill, Located on the deck area does not have the correct cap on it. This should be attended to for safety.
