Accurate Home Inspection of Illinois

Property Inspection Report For Tammy Limberopoulos 26126 S. Royal Crest Dr., Crete, Illinois

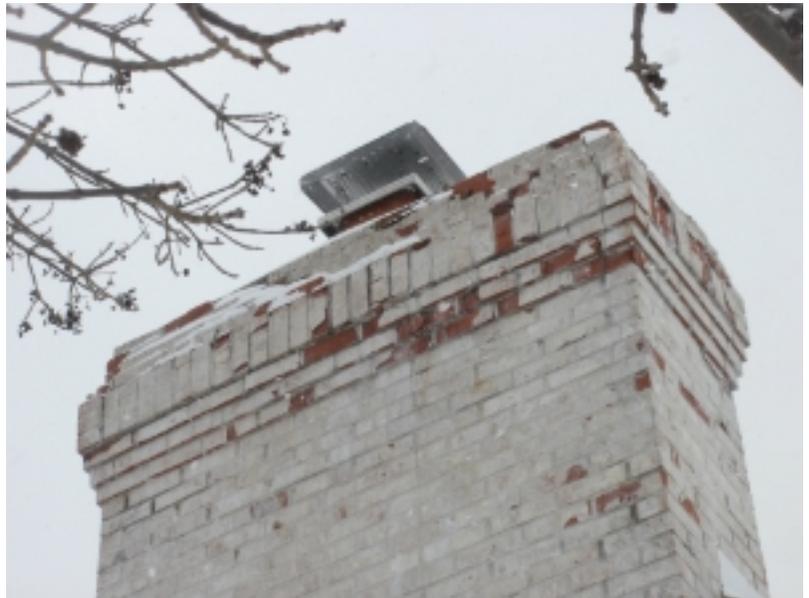
Chimney:

REPAIR or REPLACE - Mortar is deteriorated. In my opinion this allows for water to enter building. Water leakage can cause various problems to the building and can cause damages to the chimney system. I recommend that you contact a qualified contractor such as a chimney sweep or mason for appropriate corrective action.

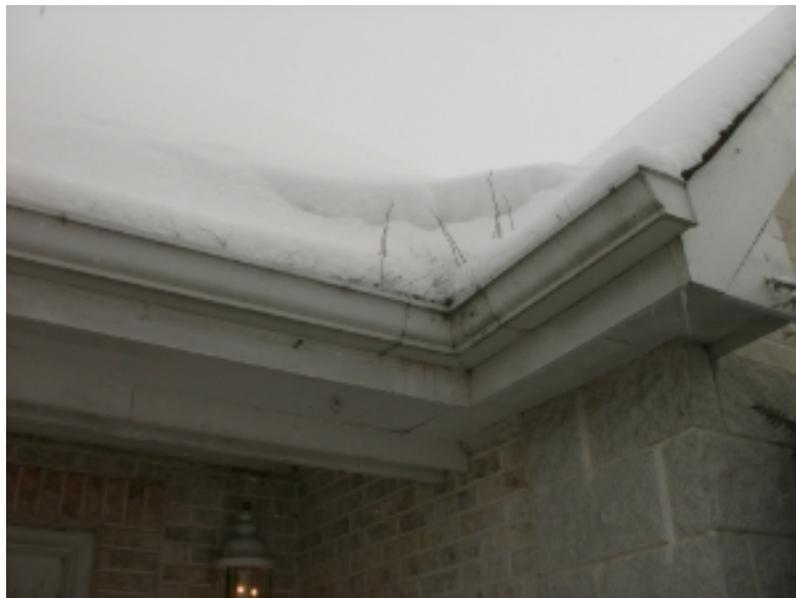
Gutters:

MAINTENANCE - Debris is blocking water flow from the gutters. In my opinion this can cause various damage including the increased potential for water leakage into the home if not corrected and cleaned out.

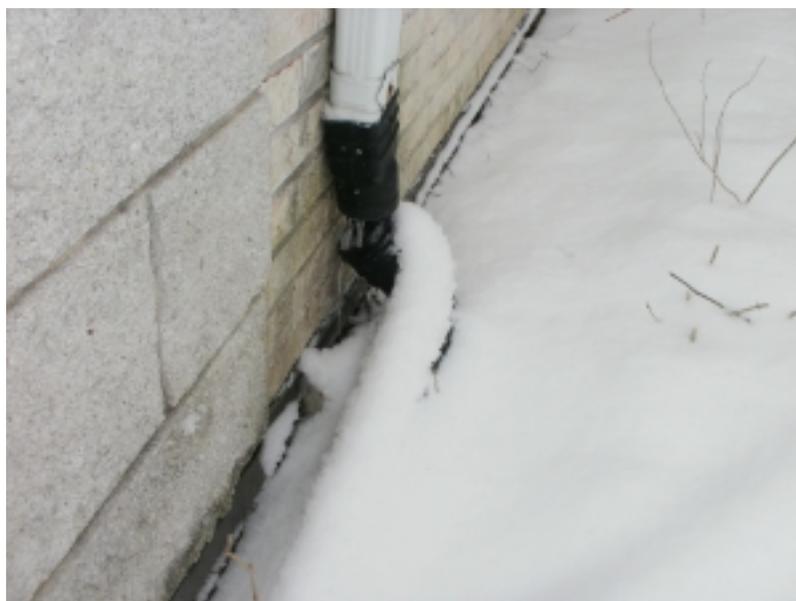
Downspouts:

REPAIR or REPLACE - The downspout discharge drains close to the house. As a rule of thumb, a minimum drainage of six feet from the house is recommended. In my opinion when drainage is closer than 6 feet there is an increased potential for water to go back to the foundation and result in water leakage into basements and crawl spaces. Water leakage can cause various problems and damage including damaging drywall, plaster, paneling, flooring and similar. Water leakage can also lead to mold problems. I recommend that you contact a qualified contractor to mitigate the situation if possible.

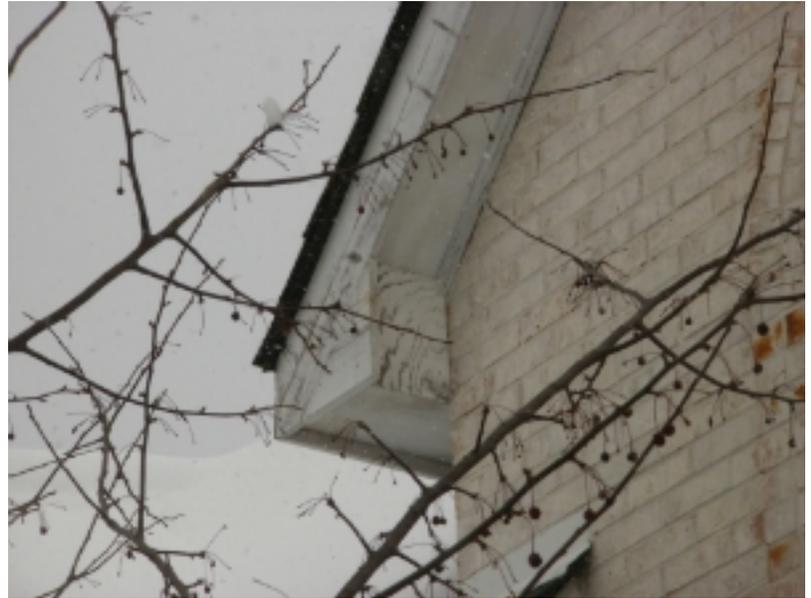
Soffit:

REPAIR or REPLACE - Bare wood is showing. In my opinion this can increase the chances for deterioration, rotting, water leakage and further damage to the building. I recommend that you contact a qualified contractor to properly repair this condition.

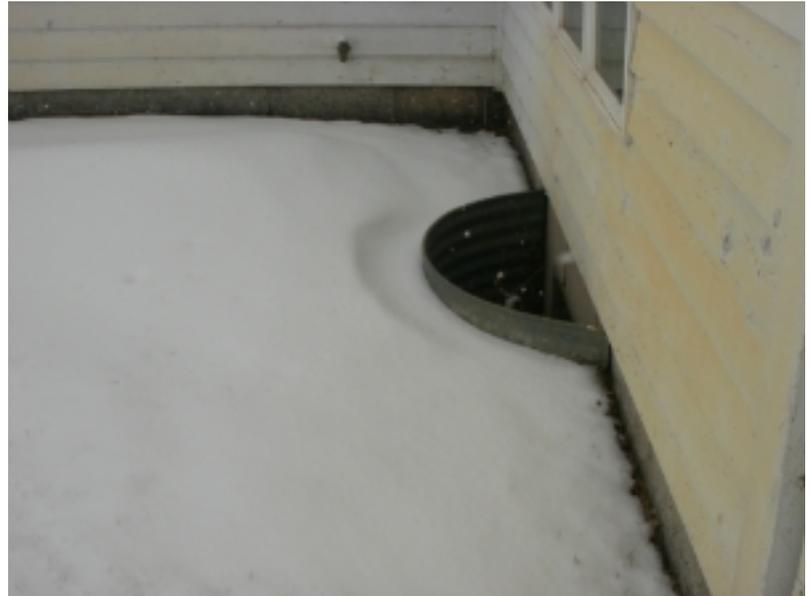
REPAIR or REPLACE - The lot grading is sloping towards the house. In my opinion this may allow for water to go back to the foundation which can result in water leakage into basements and crawl spaces. Water leakage can cause various problems and damage including damaging drywall, plaster, paneling, flooring and similar. Water leakage can also lead to mold problems. I recommend that you contact a qualified landscaping contractor or landscape architect to mitigate the situation.

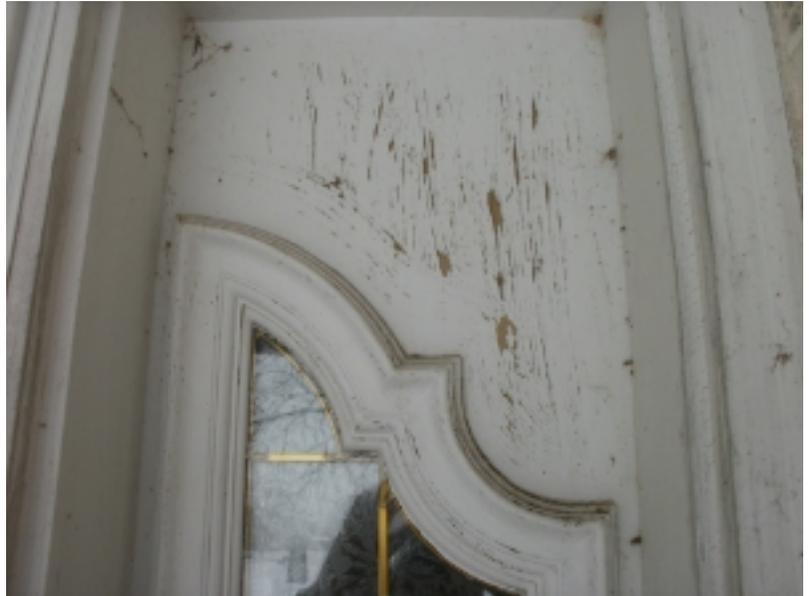
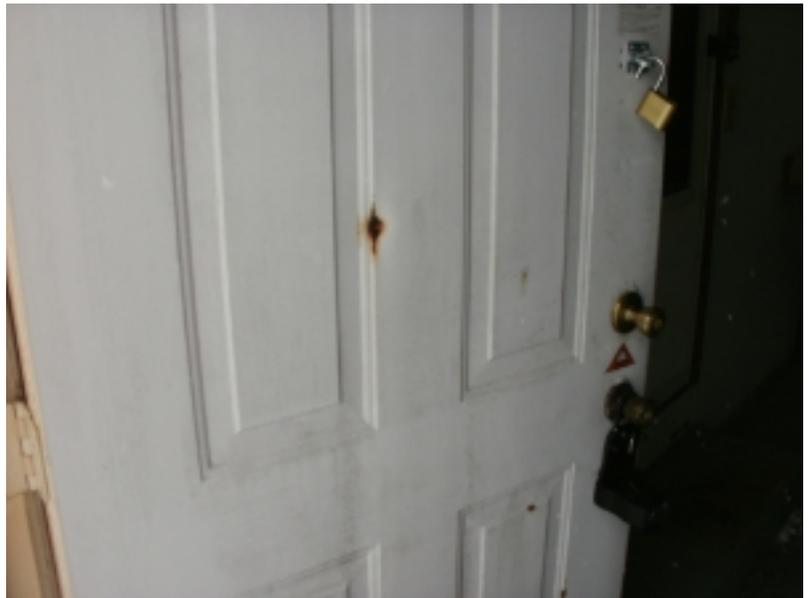
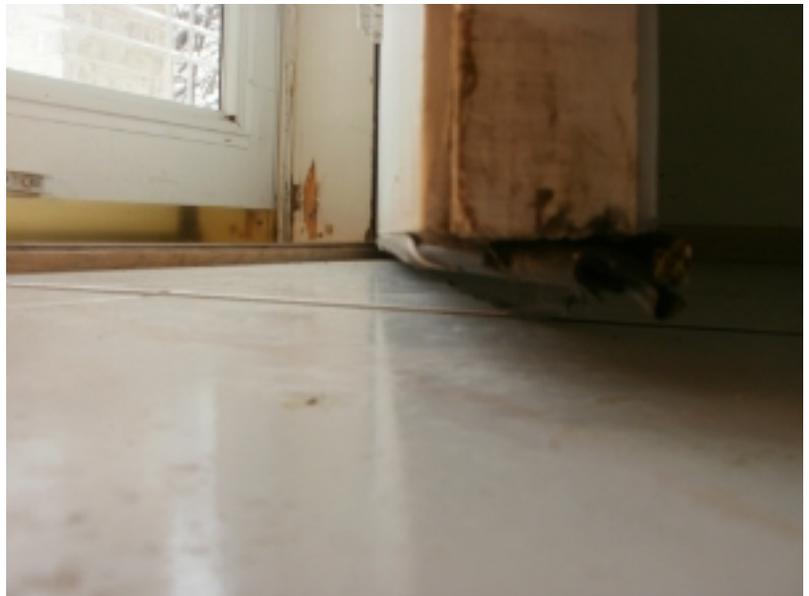
REPAIR or REPLACE - One or more of the doors has peeling paint. In my opinion this can increase the chances for further damage to the doors and/or building including deterioration, rotting and leakage. I recommend that you contact a qualified contractor to mitigate the situation.

REPAIR or REPLACE - One or more of the exterior doors has damaged weather stripping. In my opinion this increases the chance for further damage to the door and/or building. It may allow for drafts and reduce energy efficiency. I recommend that you contact a qualified contractor or handyman to mitigate the situation.

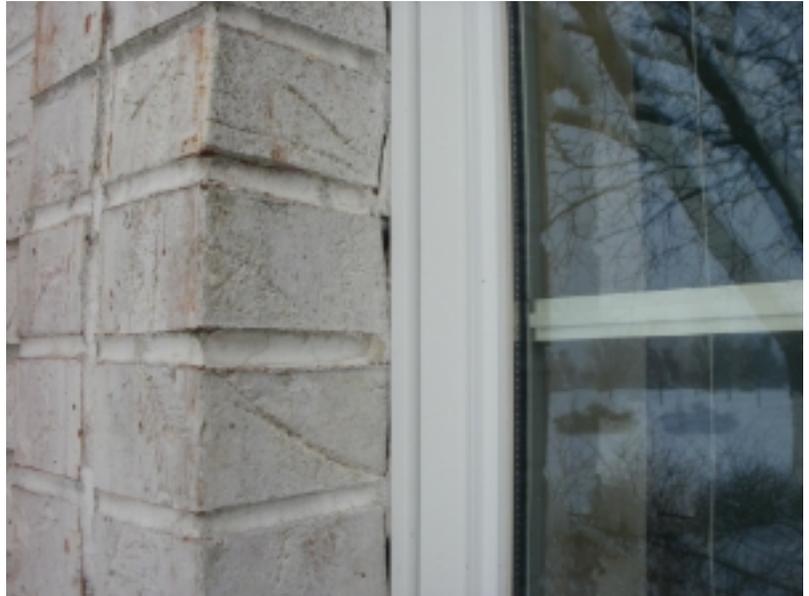
Windows:

REPAIR or REPLACE - Caulk, sealant and/or flashing detail is deteriorated, damaged or otherwise not effective. In my opinion this can increase the chances for water leakage and other moisture problems. This can lead to various damages such as at the drywall, plaster, flooring, insulation and structural framing. Water leakage and moisture problems can also lead to a mold problem. Appropriate corrective action is recommended by a qualified contractor.

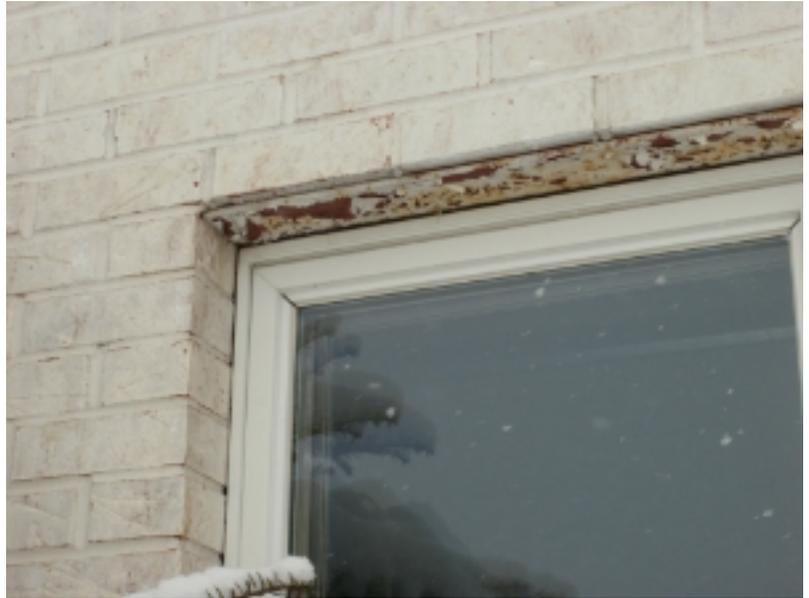
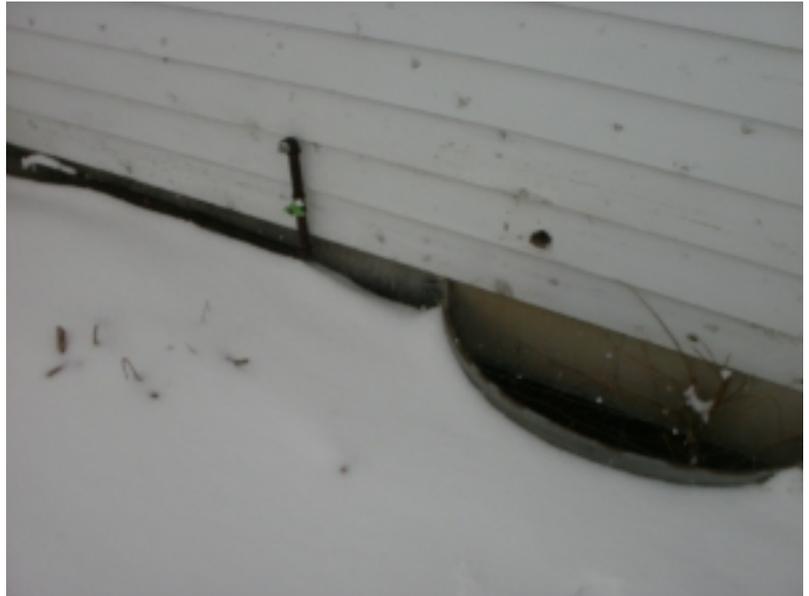
MAINTENANCE - Sections of the wall surface is in need of paint or stain. This is to protect the surface from the elements. I recommend you contact a qualified painter to mitigate this issue.

REPAIR or REPLACE - Mechanical / physical damage is present. All damage should be repaired before damage to the interior happens. A qualified contractor should be contacted to mitigate this issue.

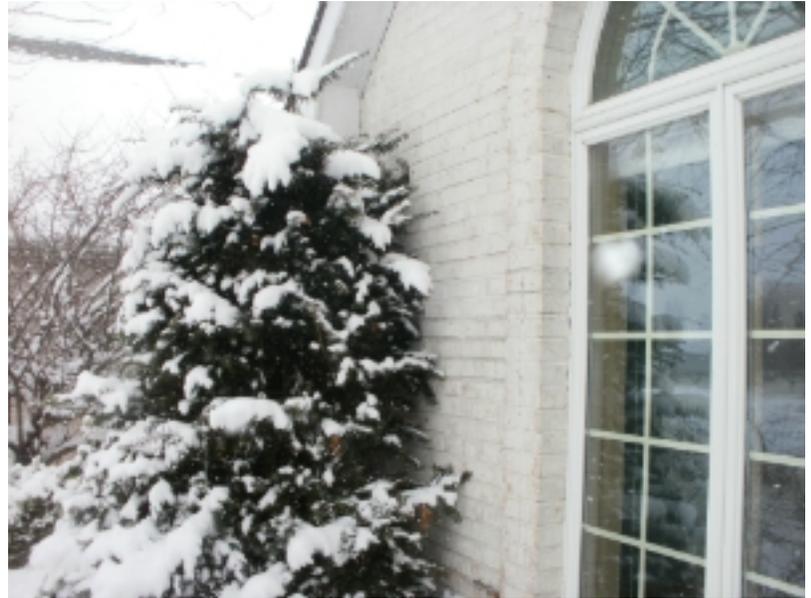
MAINTENANCE - Bushes are touching the building. In my opinion this can lead to insect and water damage to the building. I recommend that you contact a qualified landscaping contractor to mitigate the situation.

MAINTENANCE - Tree branches are overhanging the building. In my opinion this may promote the root structure to push into the building and allow tree branches to damage the roofing materials. I recommend that you contact a qualified landscaping architect / contractor for additional advice and appropriate corrective action.

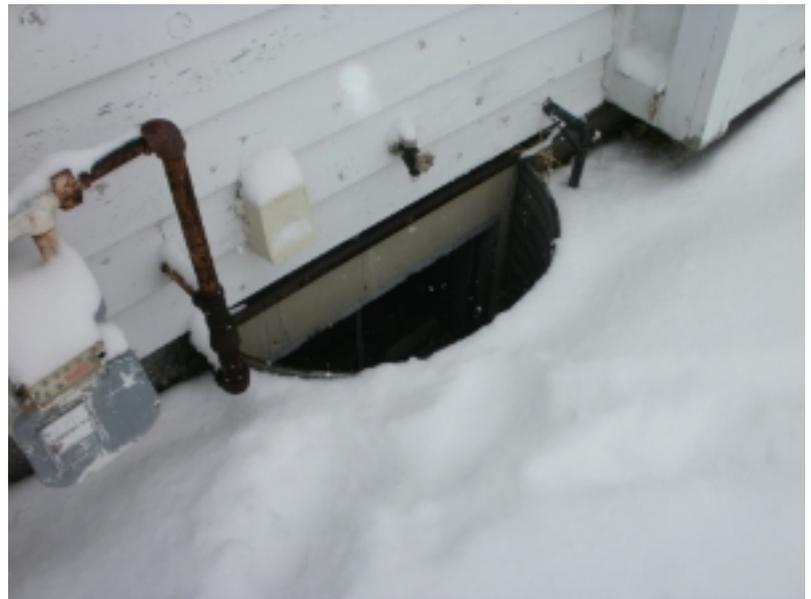
Window Wells:

SAFETY - The window wells do not have any covers on them. In my opinion, this is a fall-in injury hazard. Additionally, certain covers help to keep water out and reduce leakage potential. I recommend that you contact a qualified contractor to install sturdy window well covers.

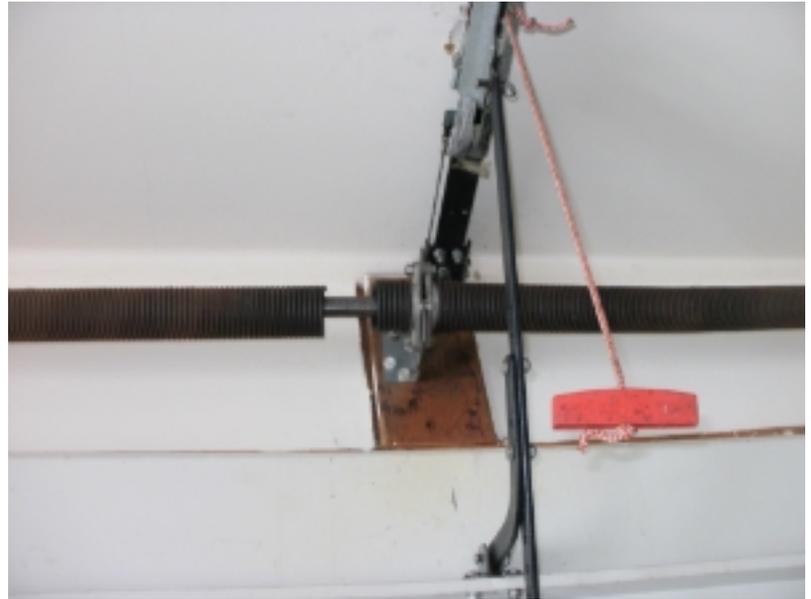
Garage Overhead Door:

REPAIR or REPLACE - Mechanical / physical damage is present at the overhead garage door torsion spring. In my opinion the overhead garage door should be repaired by a qualified overhead door contractor.

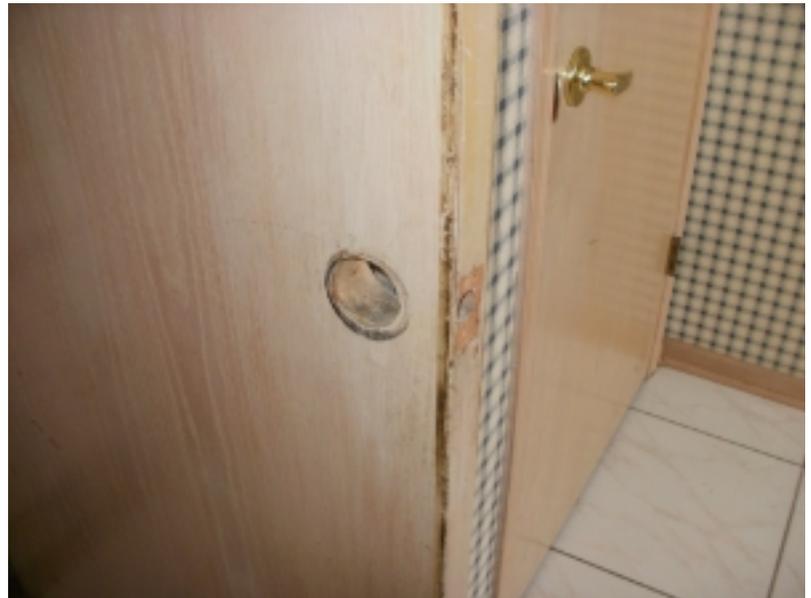
REPAIR or REPLACE - Damage is showing. In my opinion this can increase the chances for further damage to the building. I recommend that you contact a qualified contractor to properly repair this condition.

SAFETY - The garage passage door (into the house) is not equipped with an automatic door closure mechanism. In my opinion this is unsafe and is considered a fire / fume hazard from the garage. Installation of appropriate door closure is recommended by a qualified carpenter.

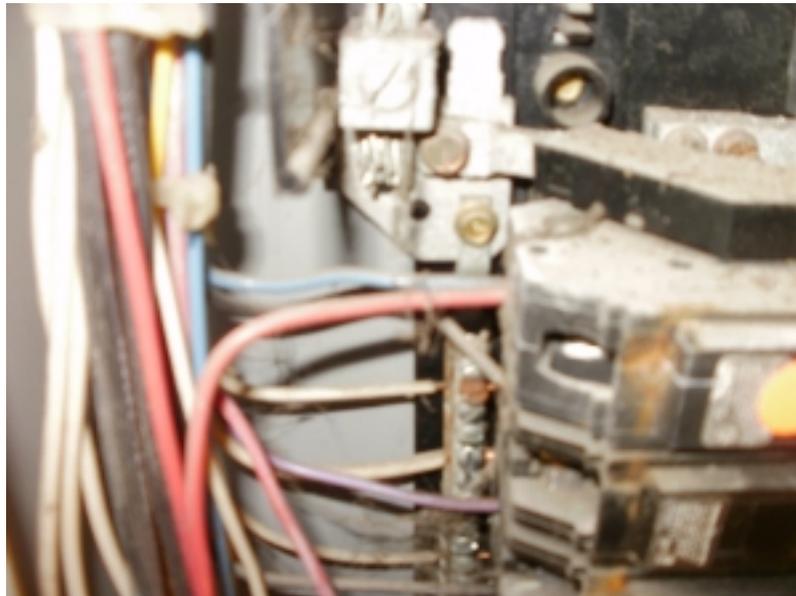
Fuses / Breakers:

SAFETY - There is double tapping at the circuit breakers (or fuses). This is considered improper and potentially unsafe. Corrective action is needed by qualified electrician.

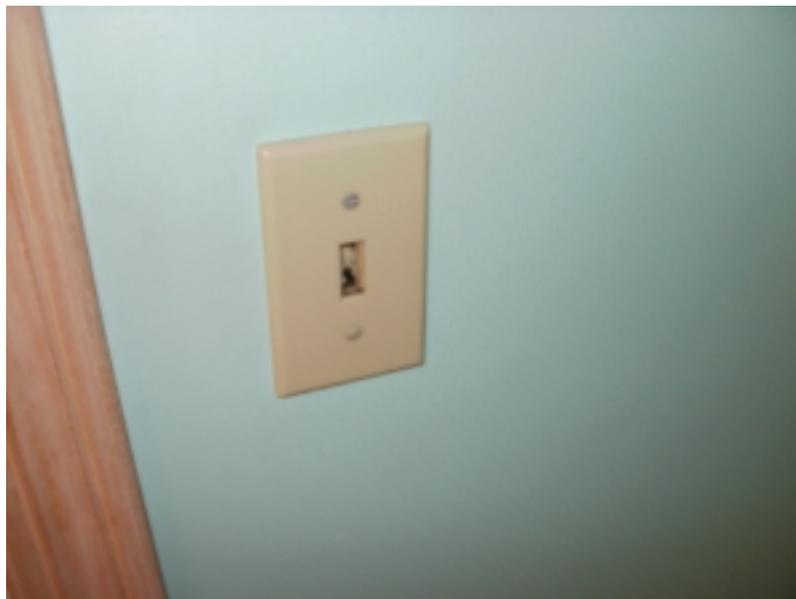
Switches:

REPAIR or REPLACE - There are switches present that do not appear operational or functioning properly. It is beyond the scope to determine why these switches are not working. I recommend you contact a qualified electrician to mitigate the issue.

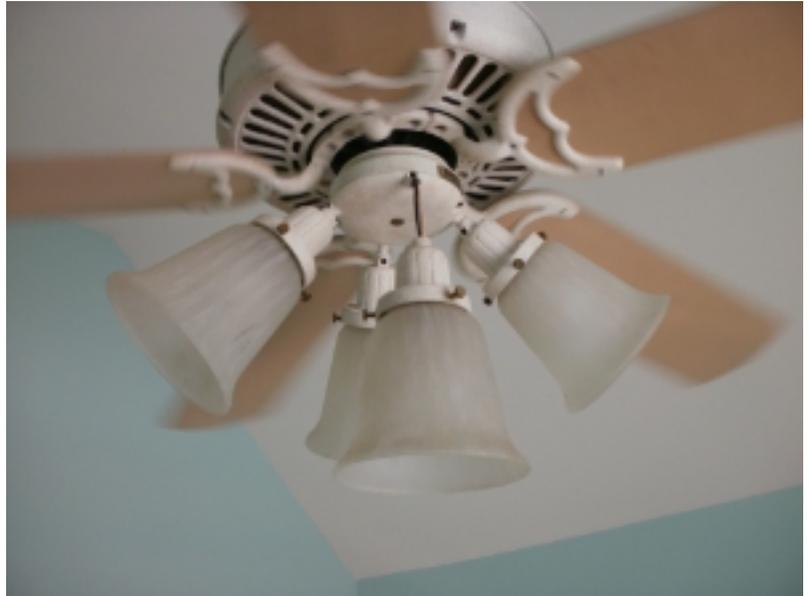
Lights:

SAFETY - Damaged light fixtures are present. This is an increased electrical shock / fire hazard. Appropriate corrective action is recommended by a qualified electrician.

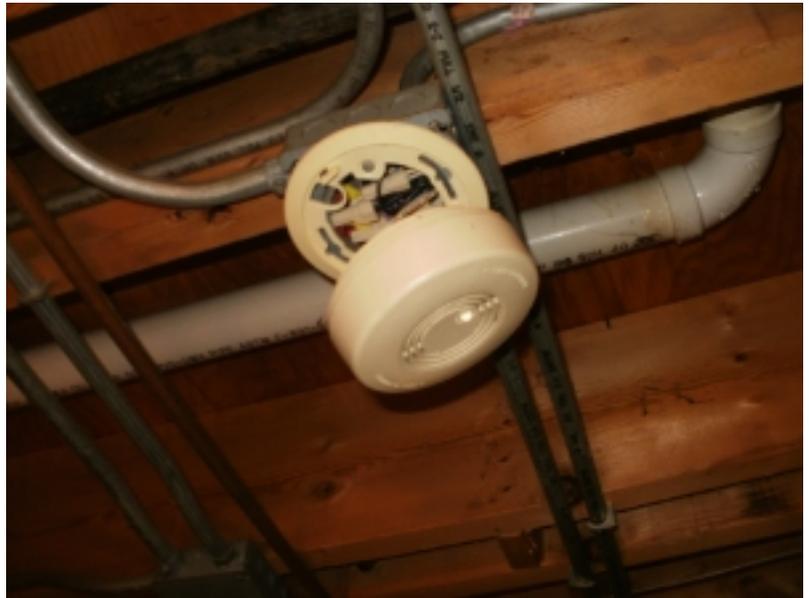
INFORMATION - Smoke detectors that are over 10 years old are considered to be unreliable and past their expected service life. Based on the age of this home and the appearance of the smoke detector(s), it is likely that they are older than 10 years old and replacement is recommended.

SAFETY - There are smoke detectors present that are not working. It is beyond the scope to determine why these smoke detectors are not working. Appropriate corrective action is recommended by a qualified professional.

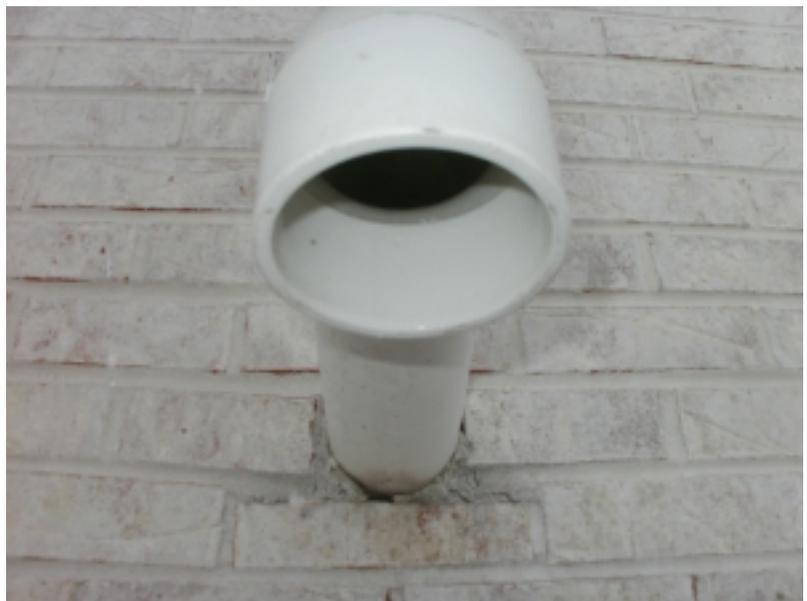
Vent:

SAFETY - The heating equipment is a high efficiency appliance that utilizes a PVC direct vent exhaust pipe. The PVC vent does not have a cover on it. This increases the potential for nesting birds etc. Nests can cause exhaust fumes to enter the house. Exhaust fumes can contain carbon monoxide. Carbon monoxide is an odorless, colorless gas that can cause illness, poisoning and death. Appropriate corrective action is recommended by a qualified HVAC contractor.

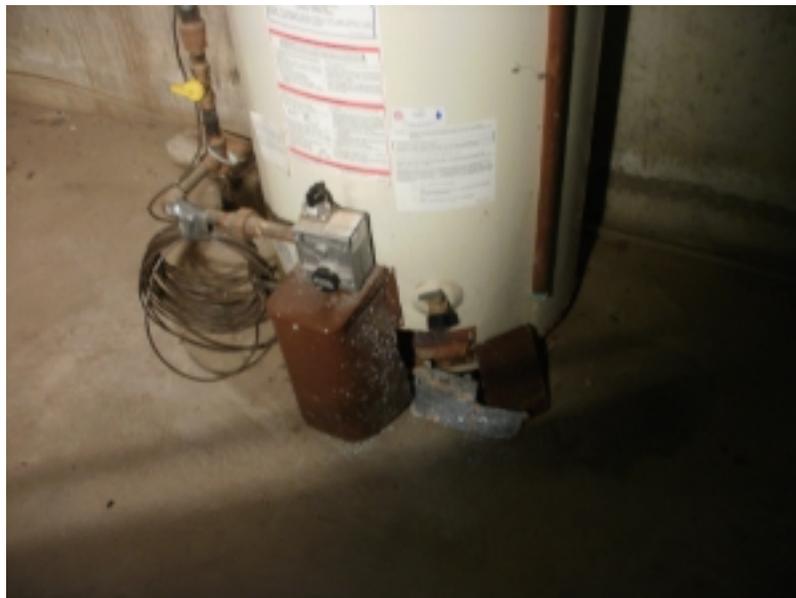
Water Heater:

REPAIR or REPLACE - Based on its age, it is my opinion that the water heater is at or beyond its useful life and should be replaced.

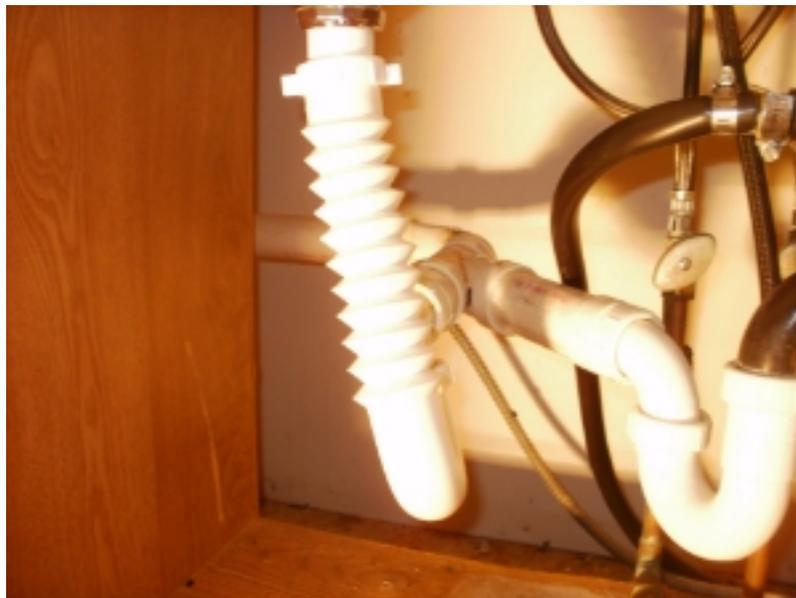
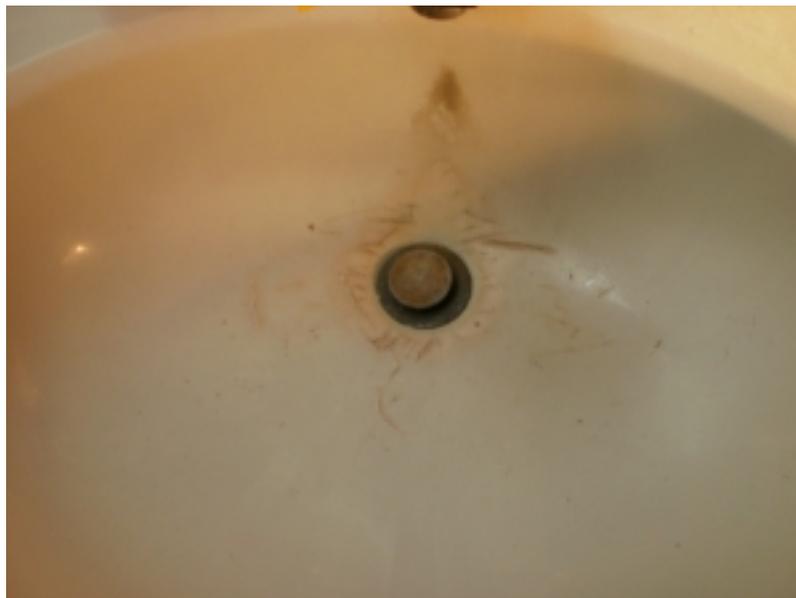
REPAIR or REPLACE - The sink drain trap is taped up or otherwise fitted with a temporary repair. The damaged trap should be replaced by a qualified plumber.

REPAIR or REPLACE - Mechanical / physical damage is present. The fixture may fail causing malfunction or usage problems. This can result in damage to the fixture or the building. Water damage can result in damages and deterioration of plaster, drywall, flooring and other finished surfaces. It can cause structural problems and lead to mold. Appropriate corrective action is recommended by a qualified plumber.

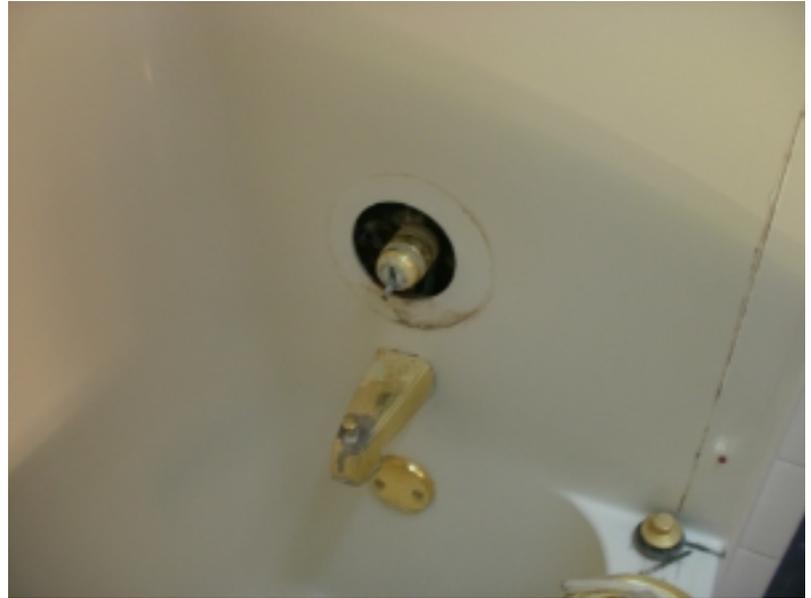
REPAIR or REPLACE - Mechanical / physical damage is present. The fixture may fail causing malfunction or usage problems. This can result in damage to the fixture or the building. Water damage can result in damages and deterioration of plaster, drywall, flooring and other finished surfaces. It can cause structural problems and lead to mold. Appropriate corrective action is recommended by a qualified plumber.

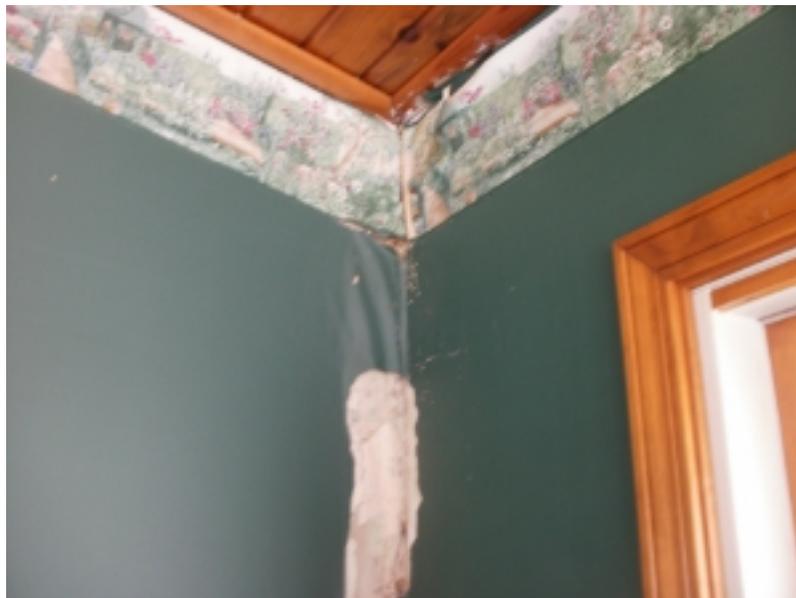
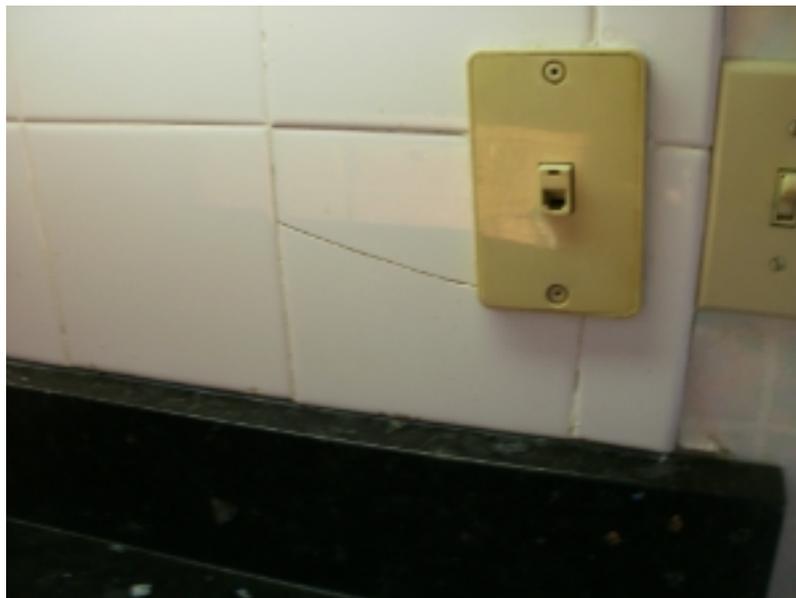
REPAIR or REPLACE - Damaged sections are present. It is my opinion that these should be fixed before someone gets hurt or additional damage is done to the property. I recommend that you contact a reputable handyman to mitigate this issue.

REPAIR or REPLACE - There are water stains on the ceiling and/or walls. This inspection cannot determine if a water leak is active or not, and cannot determine its exact cause. Water leakage into walls and ceilings causes various damage and deterioration and can lead to mold issues. Troubleshooting and appropriate corrective action is needed by a qualified contractor.

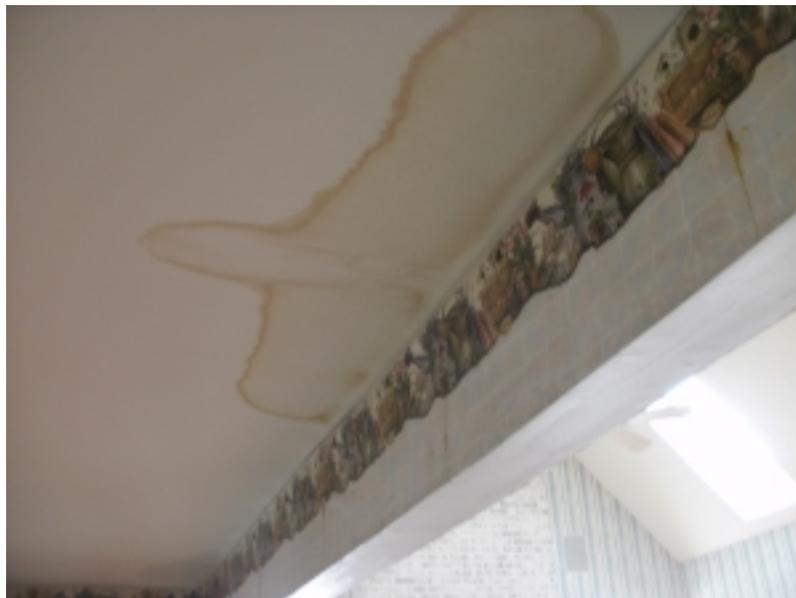
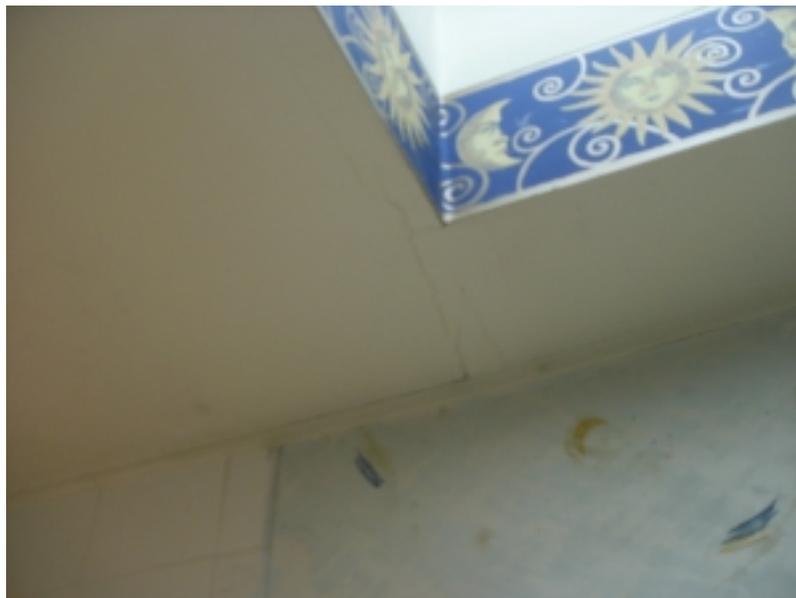
REPAIR or REPLACE - Water stains, deterioration or similar is present. This generally indicates some type of water / moisture entry. This inspection cannot determine its source or if it is active. Troubleshooting the cause and appropriate corrective action is recommended by a qualified contractor.

REPAIR or REPLACE - Typical cracks, blemishes, nail pops and similar are present. In my opinion these are common conditions and are likely to be cosmetic. Repair is recommended to obtain a better quality finish but will not likely affect performance.

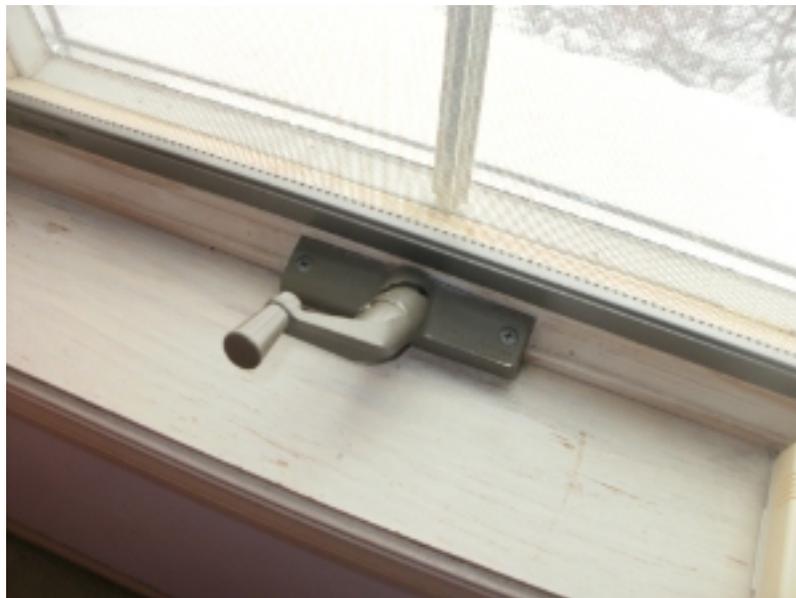
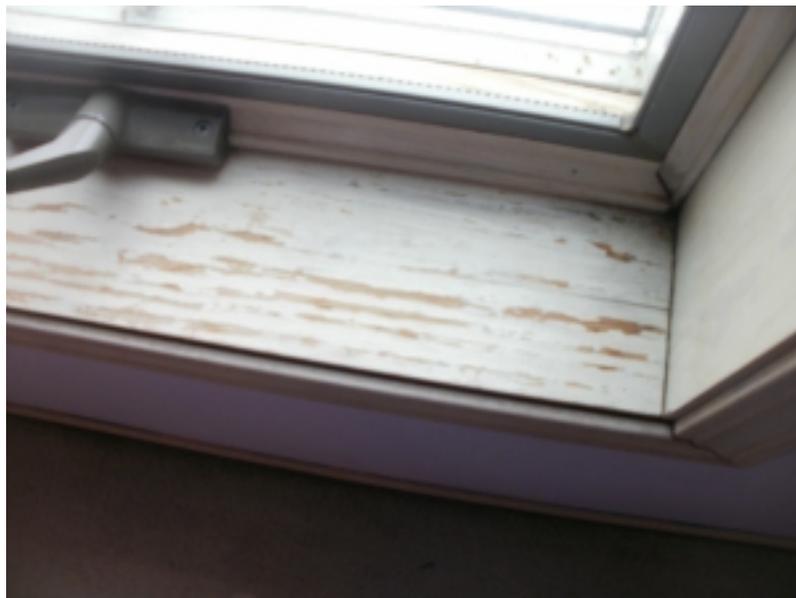
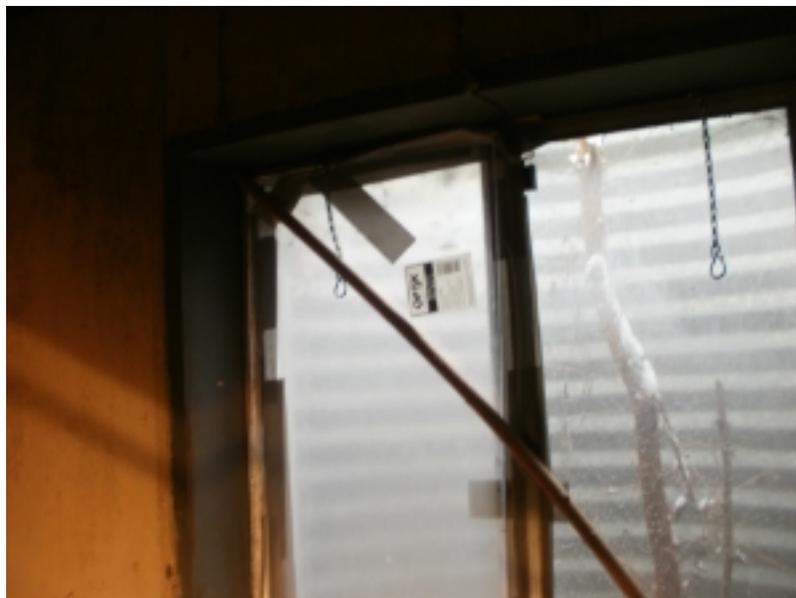
REPAIR or REPLACE - Bare wood is showing. It is my opinion that the windows are in need of paint or stain. I recommend that you contact a reputable handyman or painter to mitigate this issue.

REPAIR or REPLACE - Damaged sections are present. It is my opinion that these should be fixed before someone gets hurt or additional damage is done to the property. I recommend that you contact a reputable handyman to mitigate this issue.

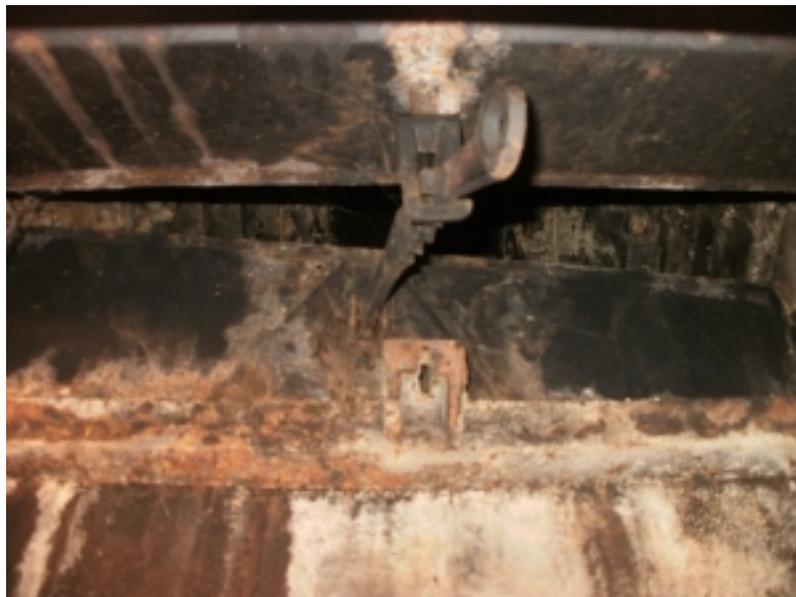
SAFETY - The steel damper is missing, damaged or otherwise not functional. This can affect the operation of the fireplace and allow animals and weather to enter the home. Appropriate correction action is recommended by a qualified chimney sweep.

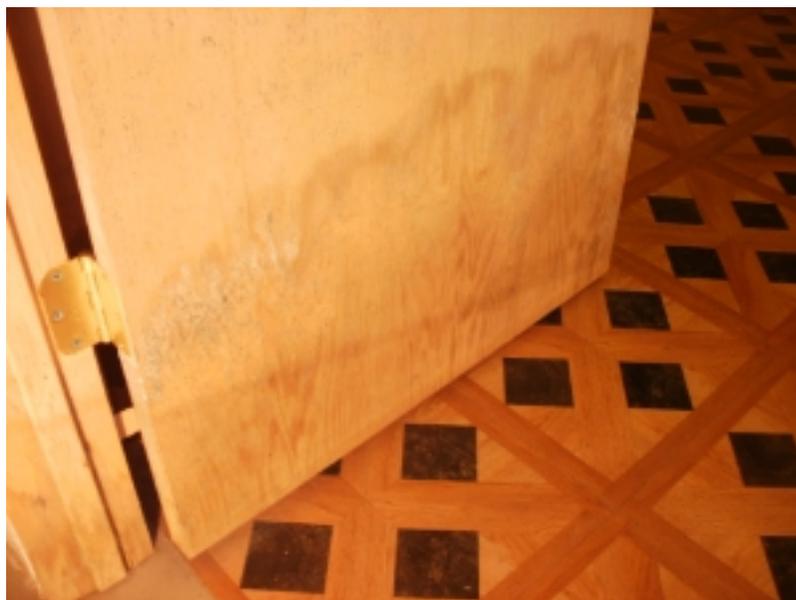
Below Grade Leakage:

SAFETY - Indicators such as stains or deterioration is present at various sections of the lower level of this home. This generally indicates some form of unwanted water entry such as seepage, leakage, flooding, drain back up or similar. This inspection cannot determine which. This inspection cannot determine how severe unwanted water entry may be in the future. Consultation with a qualified flood control and waterproofing contractor is recommended to determine the cause and remedy. Appropriate corrective action is recommended.

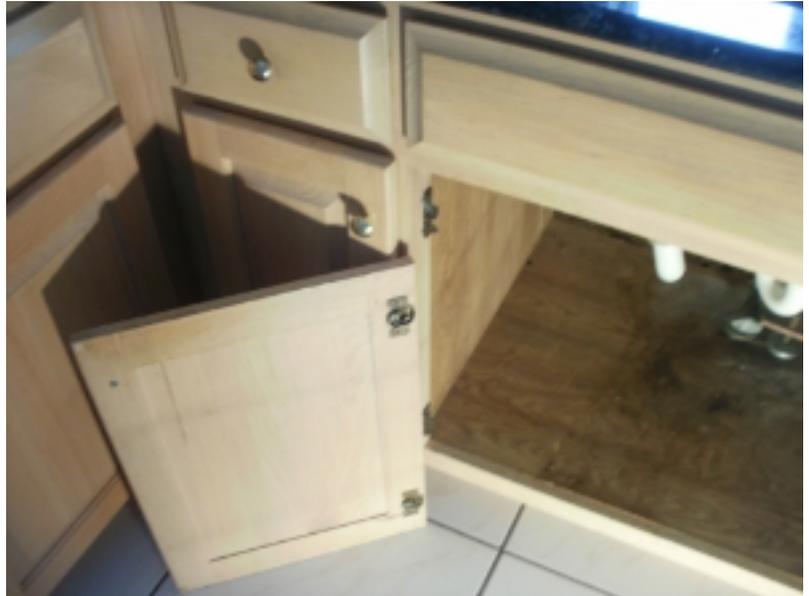
Cabinets:

REPAIR or REPLACE - Loose sections are present. It is my opinion that these should be fixed before someone gets hurt or additional damage is done to the property. I recommend that you contact a reputable handyman to mitigate this issue.

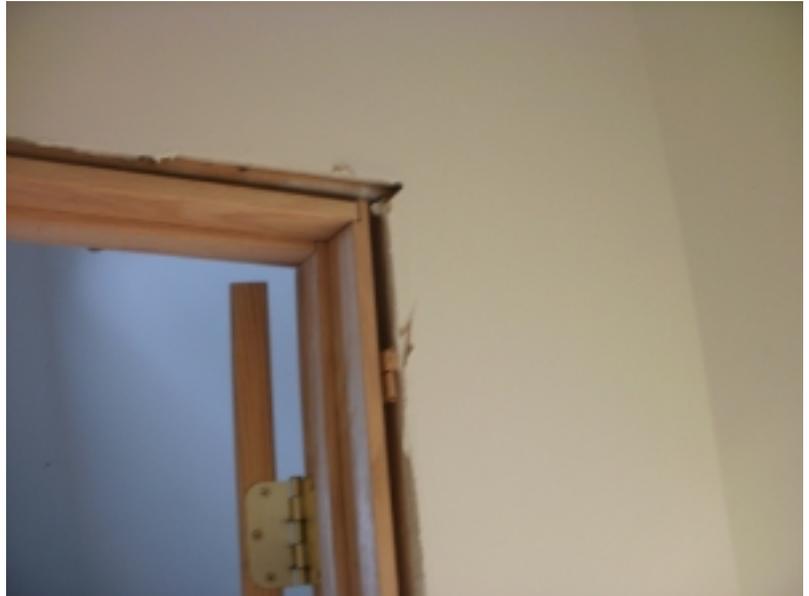
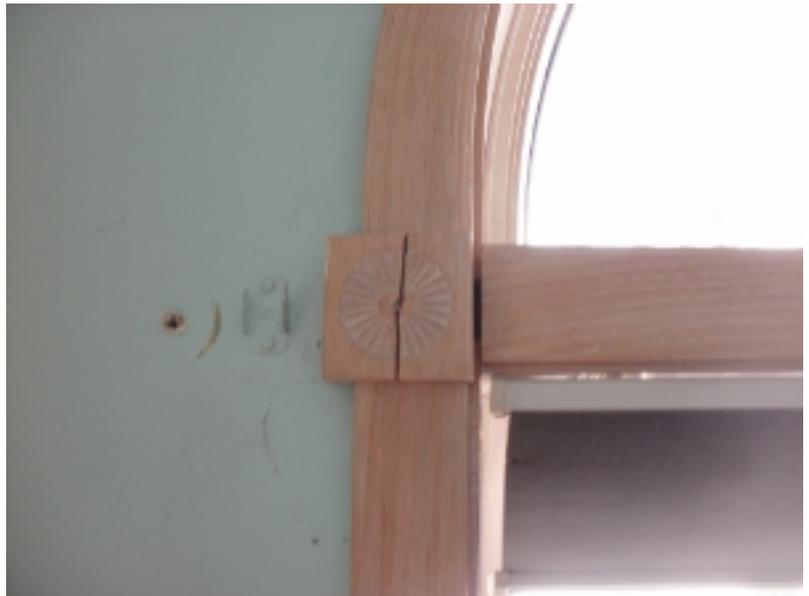
REPAIR or REPLACE - Damaged sections are present. It is my opinion that these should be fixed before someone gets hurt or additional damage is done to the property. I recommend that you contact a reputable handyman to mitigate this issue.

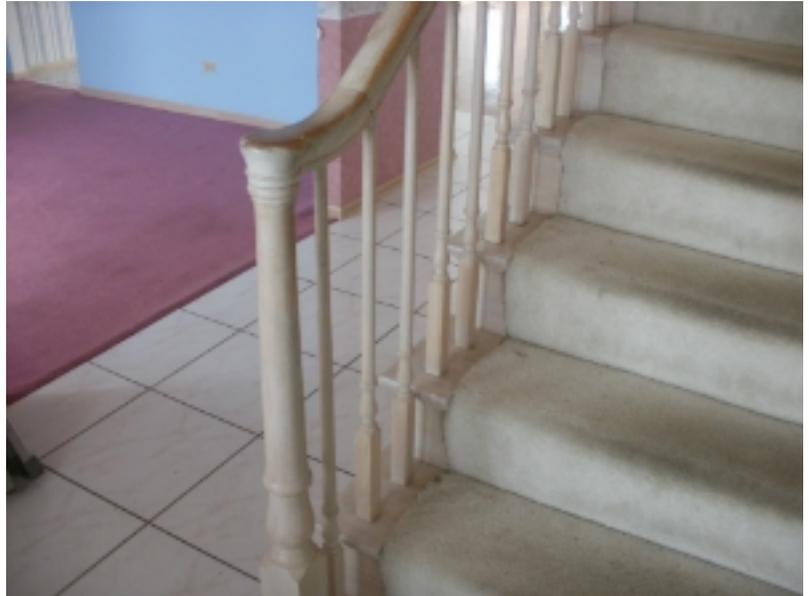
Staircase:

SAFETY - The railing(s) at the stairs is loose. This is an increased fall hazard. Appropriate corrective action is needed by a qualified contractor.

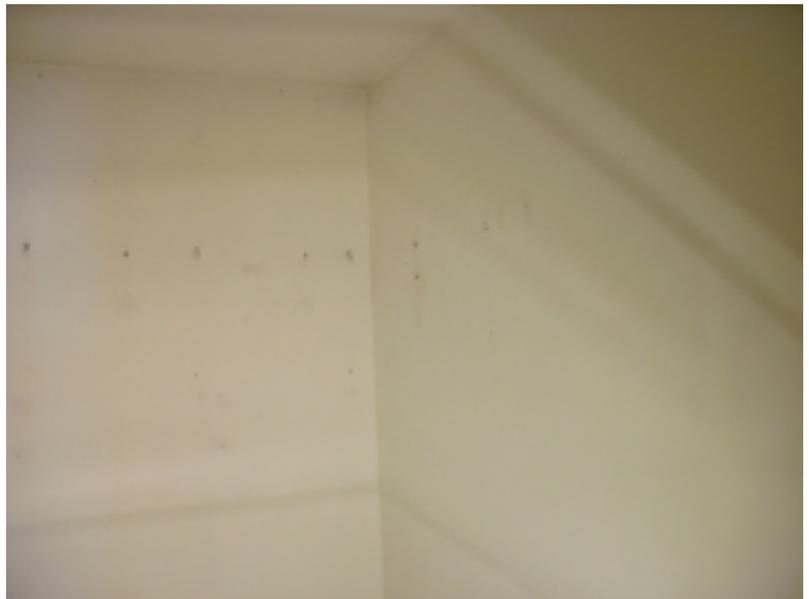
Closet:

Replace - Some of the closet shelves are missing or damaged.

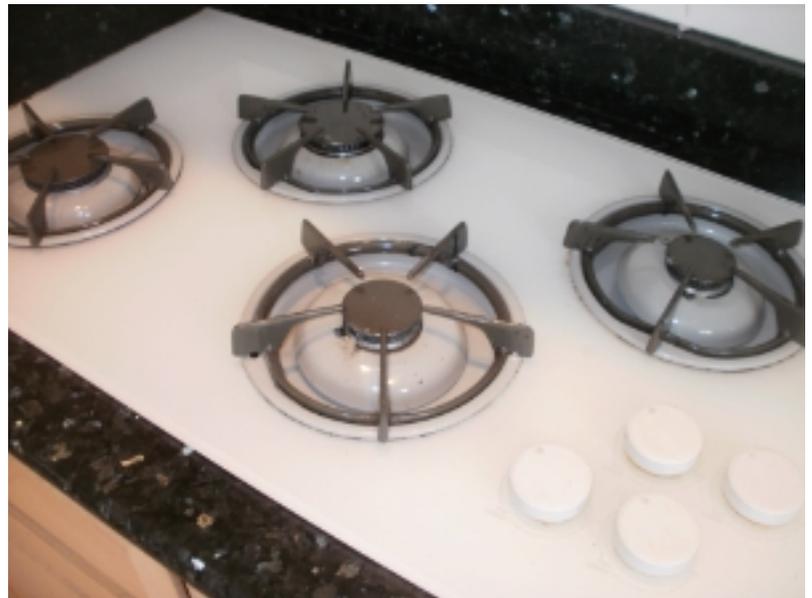
REPAIR or REPLACE - Some of the burners are not working. An appliance repair person should be contacted to make repairs to the range.

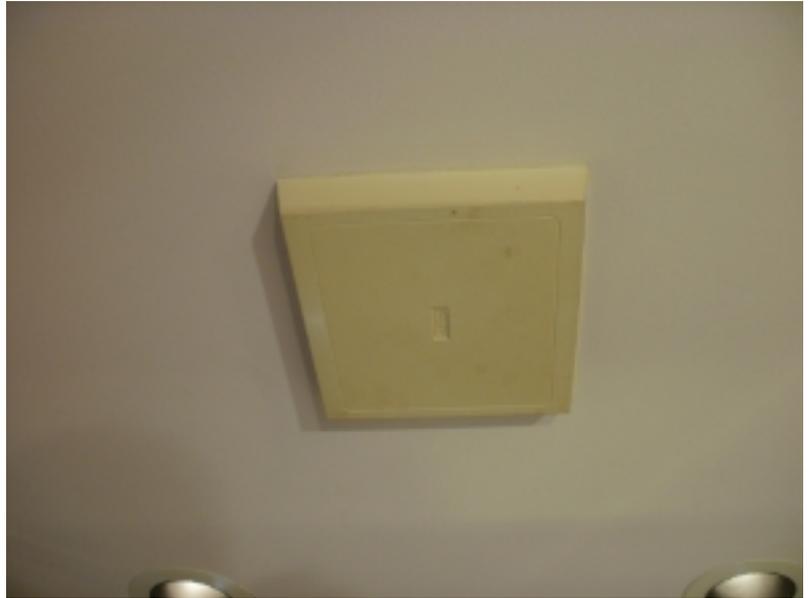
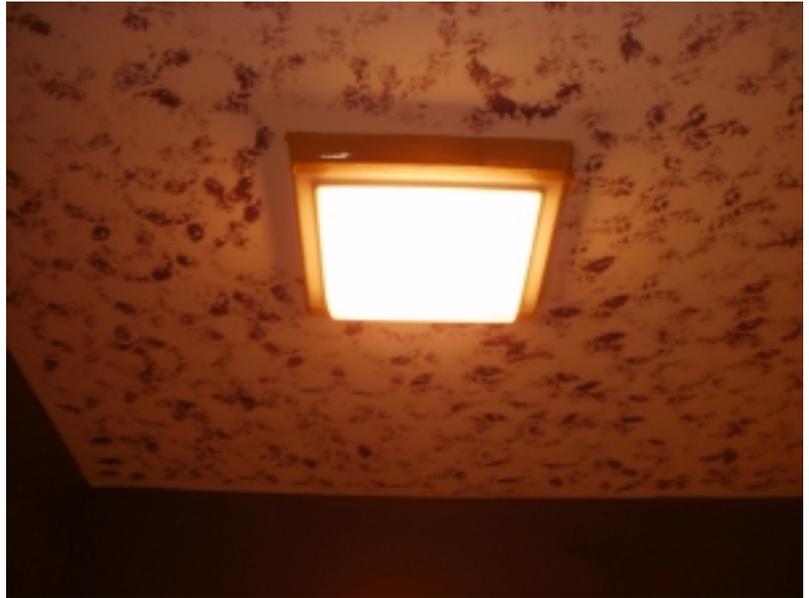
REPAIR or REPLACE - The exhaust fan is not operating when tested.
