Accurate Home Inspection of Illinois

Property Inspection Report For Tammy Limberopoulos 26126 S. Royal Crest Dr., Crete, Illinois

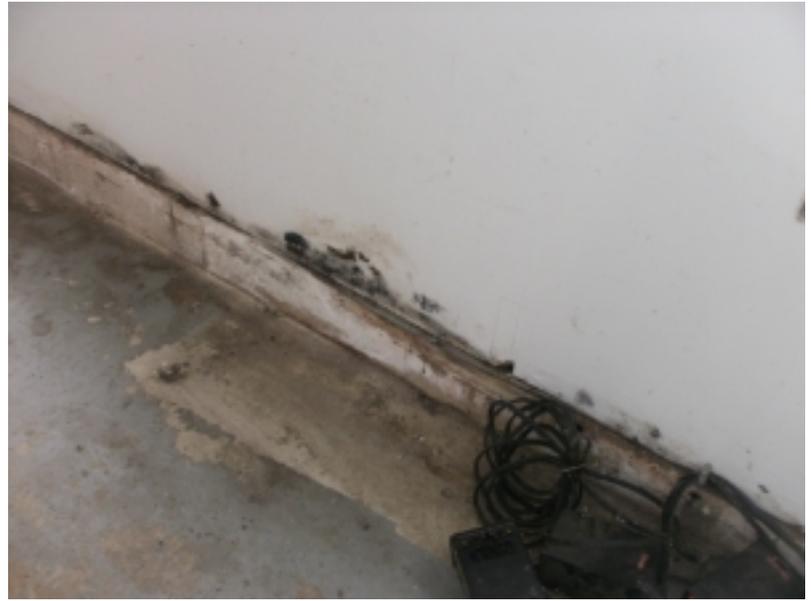
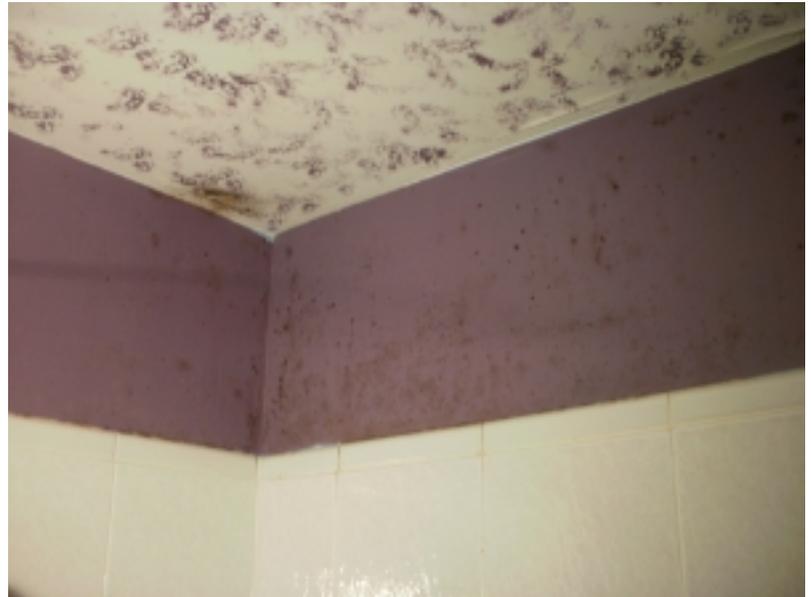
SAFETY - This inspection excludes all environmental conditions. However, discolored building materials are present and in my opinion may be mold. Mold can create an indoor air problem and is considered by some to be a health hazard. Appropriate mold mitigation is recommended by a qualified contractor. Additionally, if there is mold there is a water / moisture problem. Evaluation and corrective action of the water entry or moisture problem is needed by a qualified contractor.
